**Flood Control Project Maintenance  
Levee Inspections**

**Maintenance Issue Types Only, Levee Inspection Report By Mile - Fall 2018**

**Sutter Maintenance Yard Maintenance Area 0016**

Waterway	Bank	Unit Miles	Inspection Start/End	Inspector
Unit No. 01 Feather River	Right	4.06	09/06/2018 09/06/2018	Sterling York

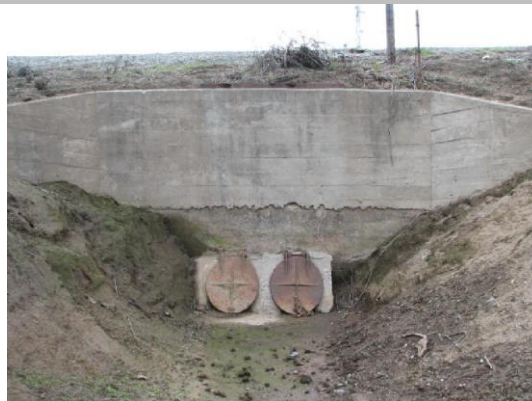
Photo 2 of 2 : UCIP\_FA\_2018\_51931\_65781.jpg

Headwall on WS toe with flap gates.

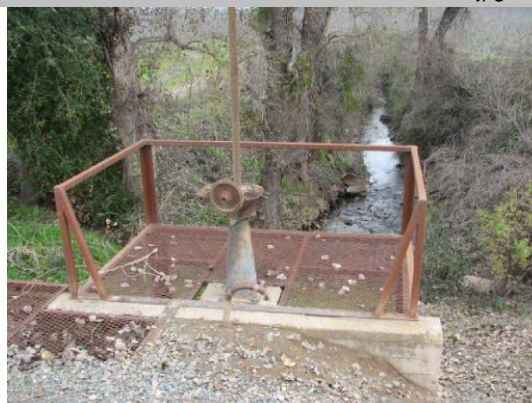
Photo 1 of 3 : UCIP\_FA\_2018\_52886\_65785.jpg

Comment Code					
Inspector Comment					
FS_ID:52886 DS_ID:17123 EP_NO: N/A Repair Type: No Action Needed Crossing Status: Found UCIP Comments: 5/22/2017 Crossing appears to be in good condition. (DWR Sutter Yard - A/Freitag)12/1/2016 Crossing appears to be in good condition. (DWR Sutter Yard- A/Freitag)5/26/2016 Crossing appears to be in good condition.6/8/2015 Pipe appears to be in good condition. No noticeable issues to report. Pipe was listed to be replaced with the SBFCA project but the project did not take place in this area.12/29/2014 Same as last inspection.5/19/2014 Same as last inspection.11/6/2013 Same as last inspection.5/14/2013 Slide gate opened allowing water to flow through, debris problem has been cleared and the gates seem to be functioning properly. SBFCA project recommends replacing in accordance with title 23.12/11/2012 Lock missing from concrete well access door-this should be resplaced. Some debris blocking preventing flapgate from completely closing. (DWR UCIP - W. Wylie) FIELD_STRUCT_DESC: 48-inch by 72-inch reinforced concrete drainage culvert through the levee, 20.5 feet below the crown. Slide gate in a concrete well on the waterside (WS) slope. Siphon breaker/air vent on the WS shoulder at the concrete well. [Additional Reference(s): DWR Levee Log, 2005. USACE Sacramento O&M Manual 148, August 1955, (Station 683+25)]. FS Date: 5/31/2017 7:36:00 AM

Slide gate, concrete well, siphon breaker/air vent and open channel on WS of levee.

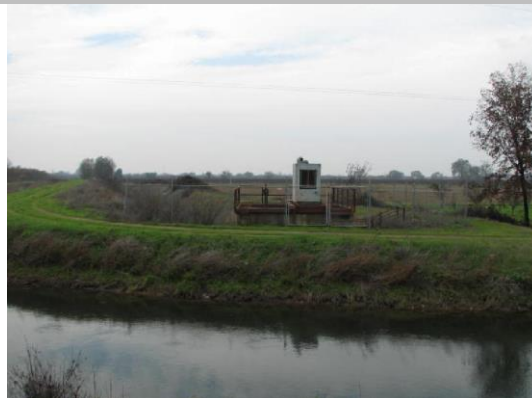
Photo 2 of 3 : UCIP\_FA\_2018\_52886\_65784.jpg

Pumping plant and slide gate on LS accross canal. (no access from levee).

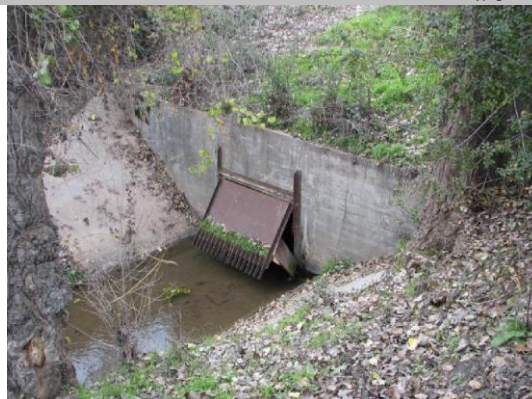
Photo 3 of 3 : UCIP\_FA\_2018\_52886\_65783.jpg

Concrete headwall and flap gate on WS toe.
